# Safe harbor

## Learning from mooring accidents

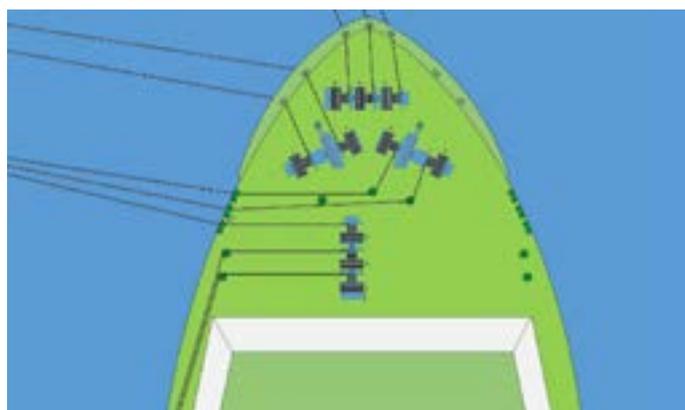
Fig 1: Zarga Mooring Deck (source: MAIB report)

Operated by Shell International Trading and Shipping Company (STASCo), the Zarga, a Q-Max LNG vessel, the largest in the world, with a storage capacity of 266,000 m<sup>3</sup>, faced a serious incident. Due to its size, it could only be moored in an exposed location at the South Hook Liquefied Natural Gas terminal in Milford Haven, UK. While repositioning the ship along the jetty during a 'warping' action using the spring-lines, one of the forward spring-lines failed. The rope, which

was made of high-modulus polyethylene (HMPE), failed in-board close to the roller pedestal that leads the rope from the winch at a 90° angle to the roller fairlead. The energy stored in the rope's PP/PET (polypropylene/ Polyethylene tereftalaat) tail resulted in a high-speed retraction of the parted rope. Due to a complex snap-back trajectory, the rope hit the officer monitoring the operation on the back of the head, even though he was in a designated safe area. The other part of the rope (running to the winch) dropped to the deck without significant snap-back.

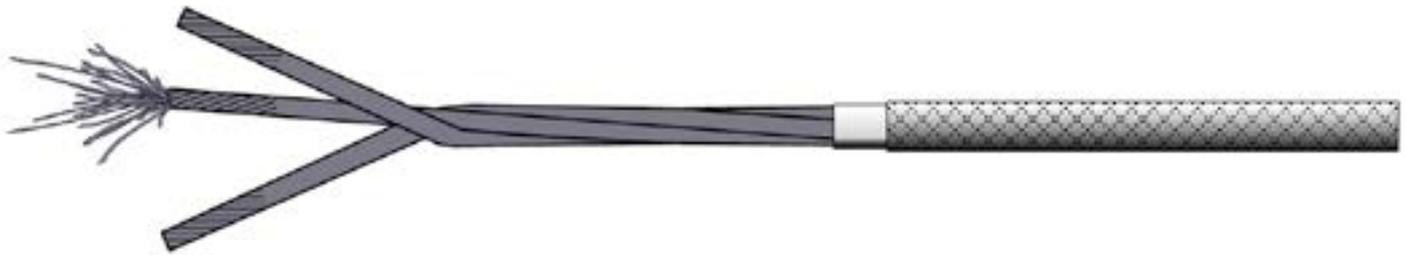
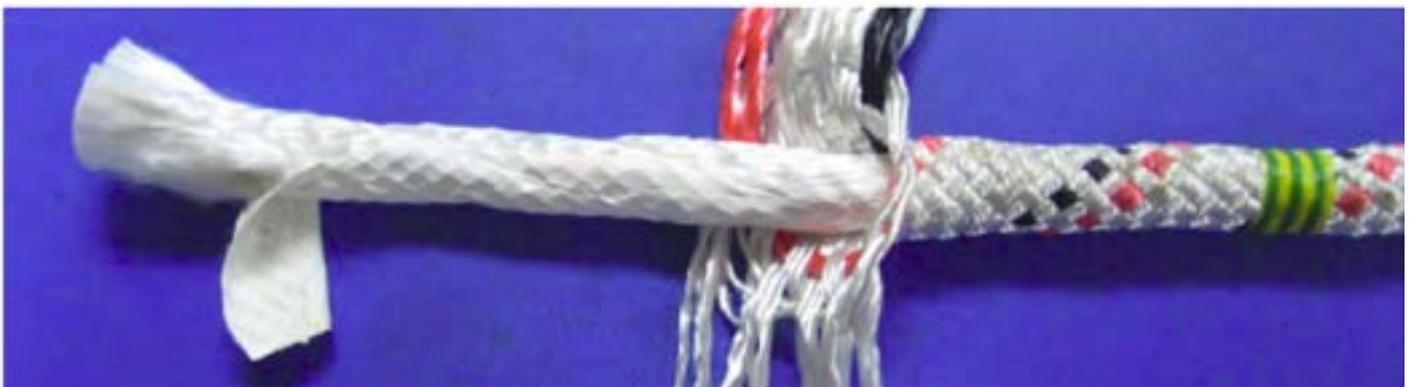
Fig 2: General view of rope with braided jacket (source MAIB report)

According to the report on the incident, from the Marine Accident Investigation Branch (MAIB) of the UK government, there was no single cause. The report states that the mooring rope failed due to overload, after its residual strength was reduced. The MAIB report further states that the reduction in the strength of the rope was the result of a combination of several factors including: high cyclic loading at exposed ports, repeated and prolonged bending and radial compression, shockloading and tension-tension fatigue and was caused by the effects of bending around deck fittings, and high levels of cyclic loading at exposed terminals such as South Hook.

The spring line which failed was a 44-mm diameter strength optimized construction of three-strand long lay strands and a jacket. It has a Dyneema® sk75 core, the braided jacket was made from polyester (PET), and the two were separated by self-amalgamating tape. The 275m rope was equipped with a 22m long, 88mm diameter PP/PET tail.

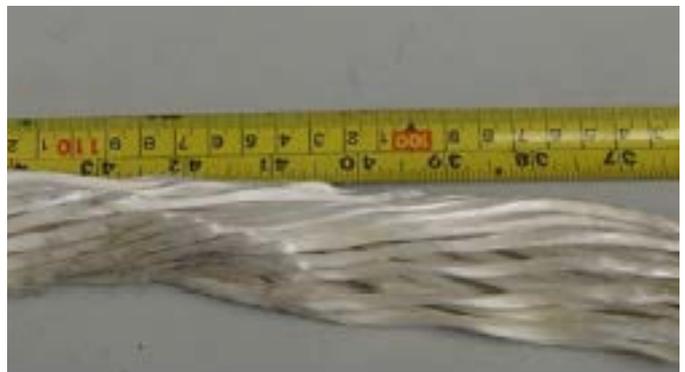
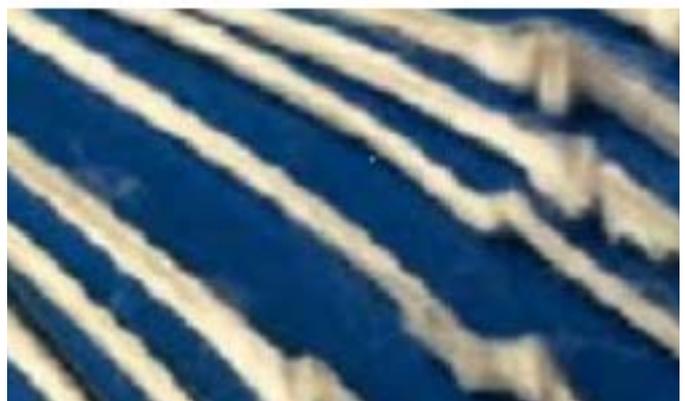
Fig 3 & 4: Yarn kinks (source MAIB report)

According to the report, one of the problems with the mooring rope was the long lay-length of the rope core and rope-yarn with very low twist, combined with the self-amalgamating tape and the very tight PET jacket. In this type of construction, kinks already introduced into the rope during production become even more severe when subjected to axial compression. It is DSM's believe that this can lead to a local aggregation of fiber which results in kink-zones -because the rope cannot expand due to the tight cover- internal friction increases leading to extreme local abrasion. As a result, the remaining intact rope yarn is more likely to fail through overload.

The report concludes that, even though the rope was made with Dyneema® sk75 fiber, the method of rope design used was unsuitable for mooring of Q-Max vessels. As a result, the rope supplier has withdrawn the product from the market for this type of vessel. To ensure that mooring ropes fully meet all requirements, DSM recommends a detailed analysis of the hardware, the type of mooring operations, and the environmental conditions at the various ports the vessel calls. DSM can support customers in performing this analysis, advising on rope design, coatings, and end-connections. DSM also recommends performing creep calculations on the mooring ropes to ensure proper lifetime in warm environments like the Middle East. Following this analysis, the rope manufacturer can design a fit-for-purpose rope.

The new guidelines will place more emphasis on rope construction, with recommendations for buyers to not only focus on mooring rope strength but to ask rope manufacturers more pertinent questions on topics like the materials used in the fibers, the construction of the rope, the linear density of the load-bearing core, coatings, and insights into material wear mechanisms. Several new tests will be detailed in MEG-4 that rope manufacturers will have to comply with to prove their ropes are fit for purpose as mooring lines for these large tankers.
