Chlorine dioxide bleaching tower

Kimberly-Clark

It pays to innovate with GRP equipment. The Kimberly Clark Corporation reported, as far back as 1966, success stories on the use of GRP for bleach towers, process piping and other chemical plant, in highly corrosive service conditions at their pulp and paper mill in Anderson, California.

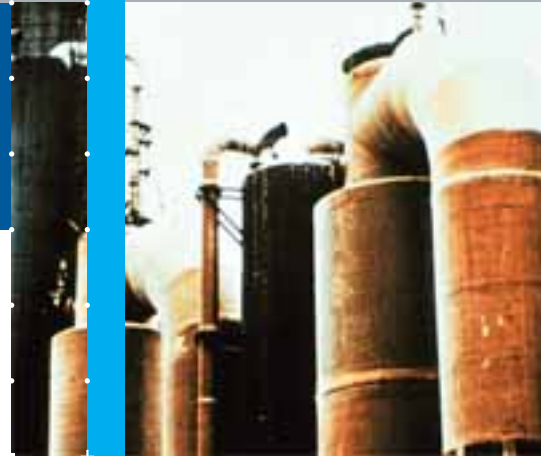
One dramatic example of saving is the case of the two identical towers. Constructed entirely of reinforced Atlac, the main tower downflow section is 3.30 m internal diameter, and about 13.5 m high. The pre-retention section is 2.10 m diameter and length is 7.5 m. Laminate thickness is around 12.5 mm for the pre-retention section, reducing towards the elbow section. The main

tower tapers from 25 to 10 mm at the top. The design was based on wind loading exceeding 160 km/h and Zone 2 seismic stresses.

The first concern was the tight plant construction schedule. But by using GRP, Ceilcote could build each tower in three sections - onto bases laid in advance. The towers were constructed on the job site in nine days. Resultant savings on fabrication and field construction are conservatively placed at 30% compared to tile-lined steel towers - which would require several months for erection and lining.

The two towers withstood 35 years of continuous service before the facility was purchased by Shasta Paper in 1999 and de-commissioned in September 2001. Operation of the plant site as a paper mill is no longer viable due to the division of the Shasta Paper Company property and the relinquishment of permits.
